**A Recommendation for an
ENHANCED FUJITA SCALE
(EF-Scale)**

**Submitted to
The National Weather Service
and
Other Interested Users**

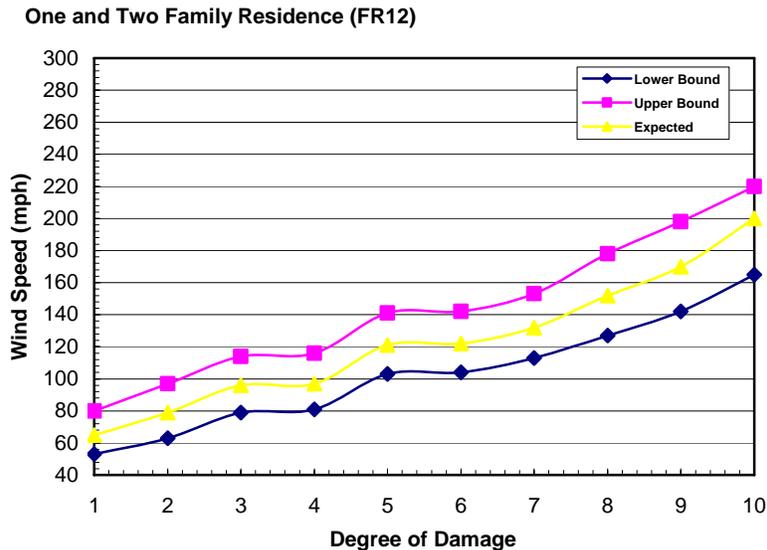
part of the sequence described above. Occasionally an entire house will shift off its foundation when not securely anchored to the foundation. The house is simply sitting on the foundation with no anchors. After shifting off the foundation, additional damage may occur.

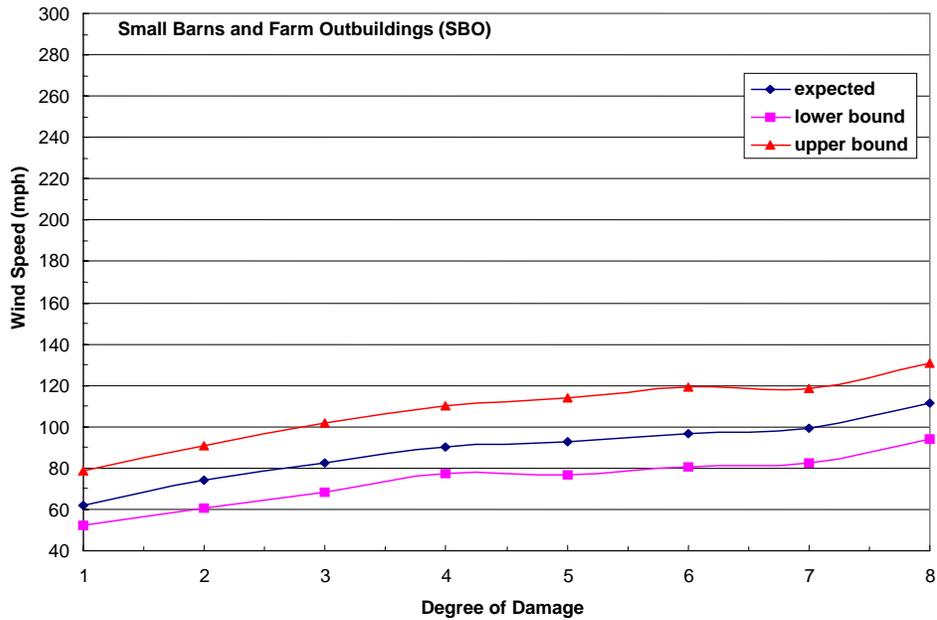
2. ONE-AND TWO-FAMILY RESIDENCES (FR12) (1000 – 5000 sq. ft.)

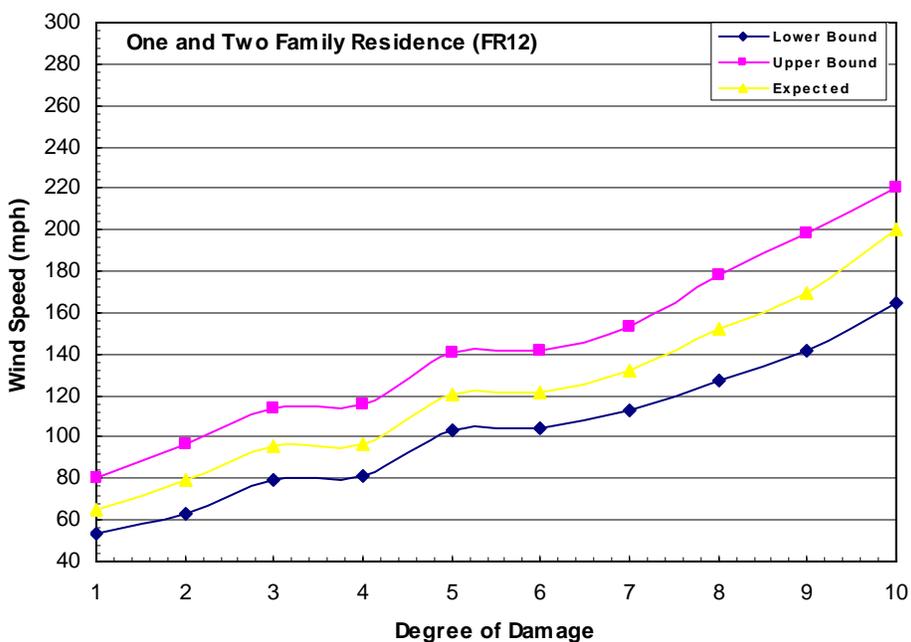
2. ONE-AND TWO-FAMILY RESIDENCE (FR12)

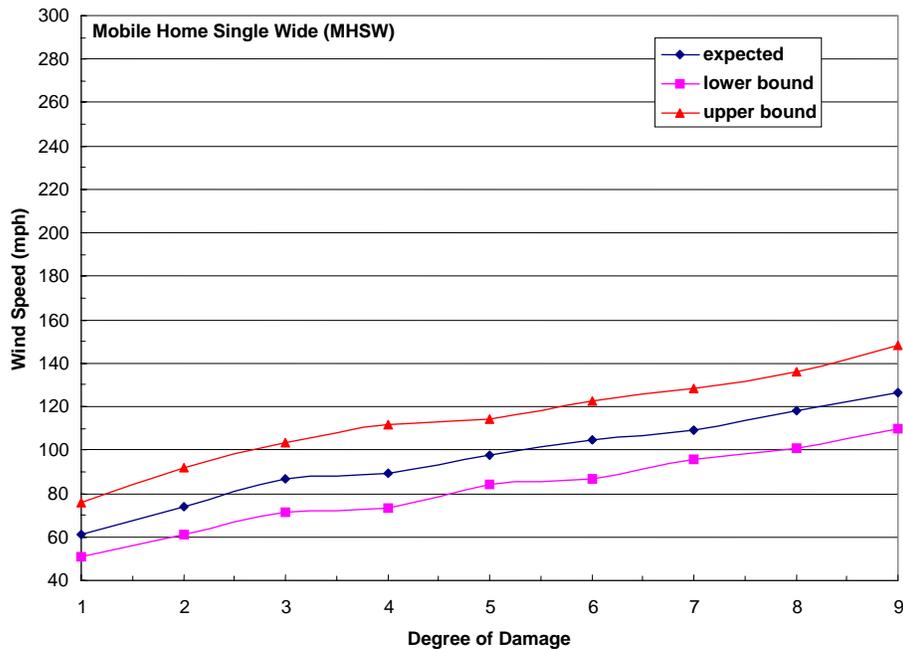
3. MANUFACTURED HOMES – SINGLE WIDE (MHSW)

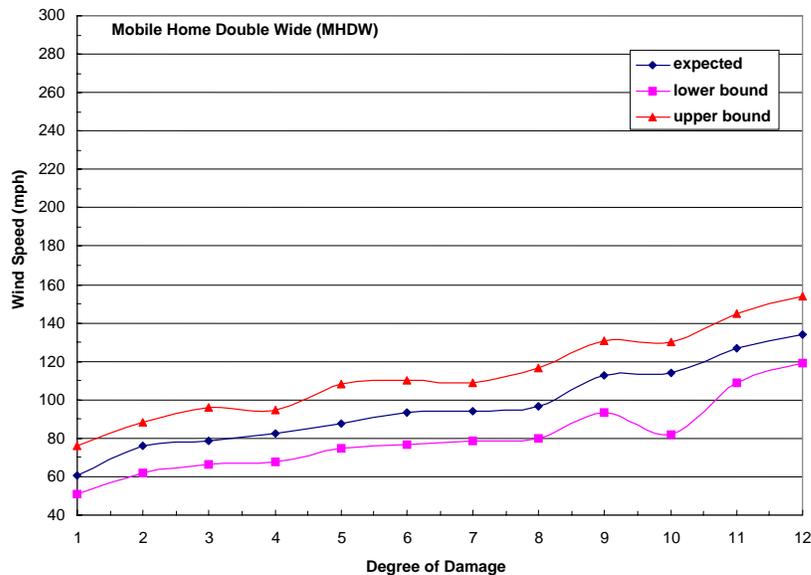
MANUFACTURED HOME – DOUBLE WIDE (MHDW)

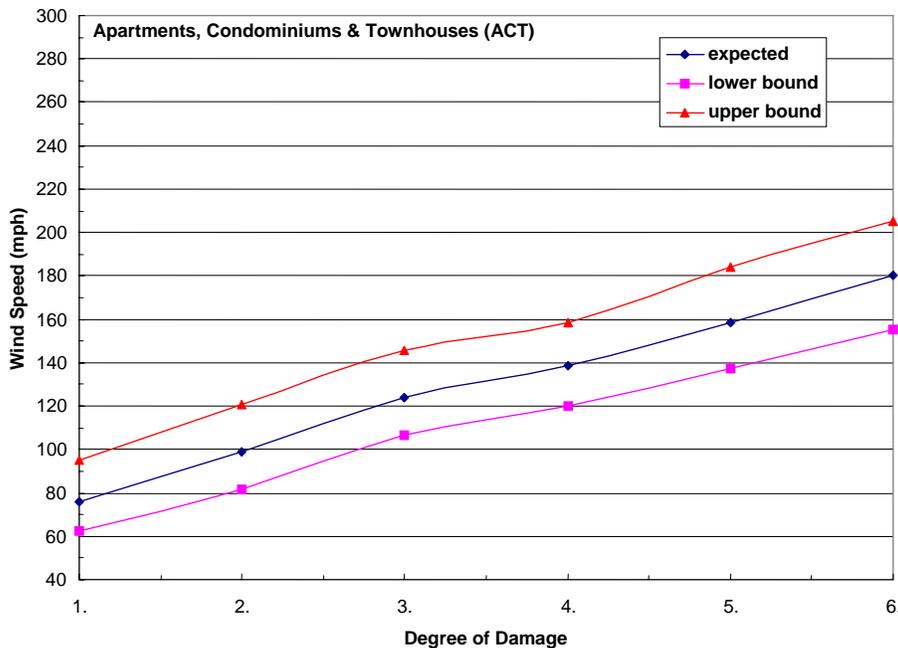
5. APARTMENTS, CONDOMINIUMS AND TOWNHOUSES (ACT)

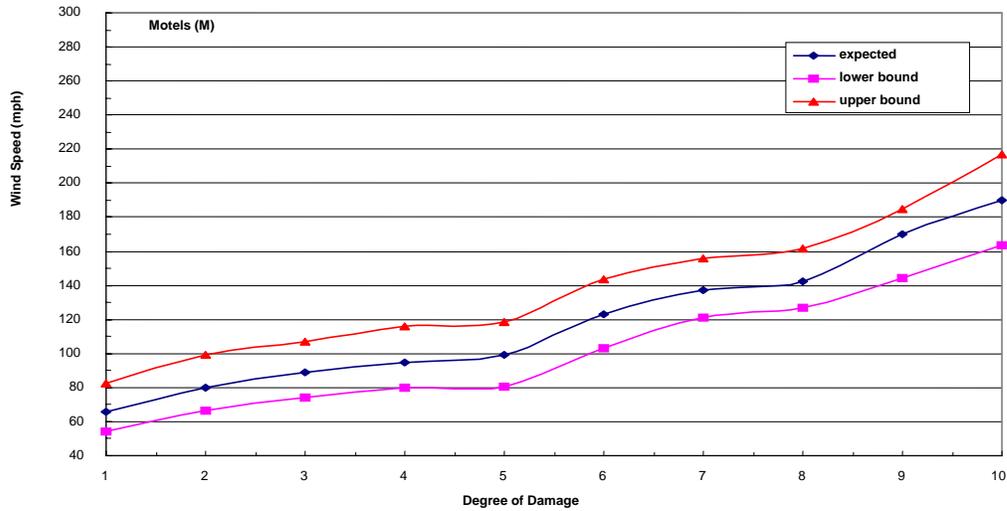
* DOD is degree of damage

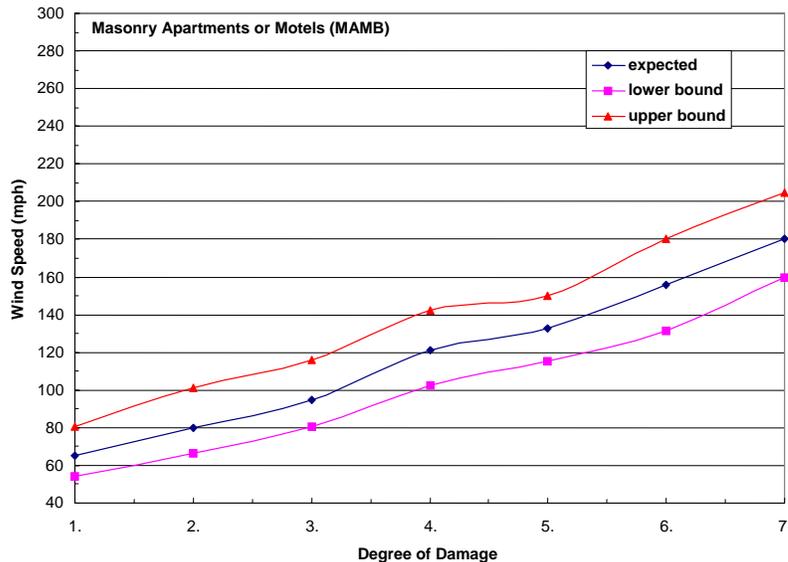
7. MASONRY APARTMENTS OR MOTEL (MAM)

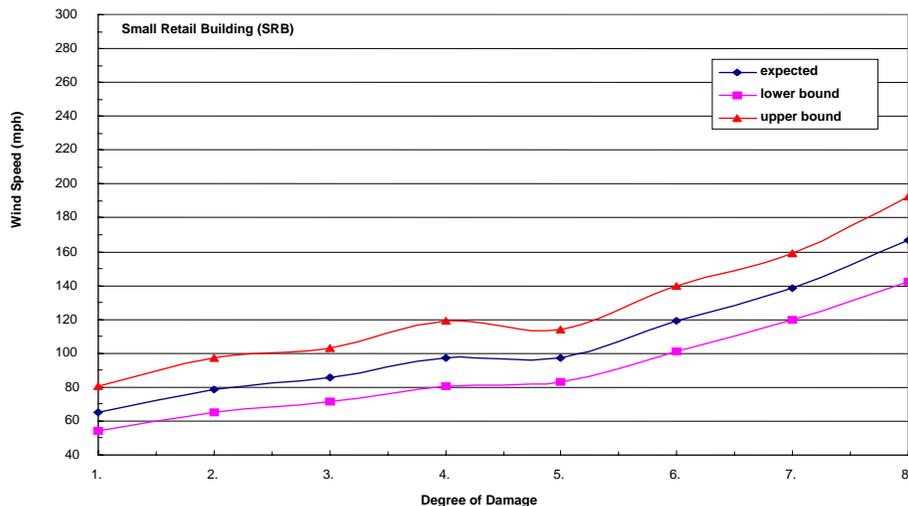
8. SMALL RETAIL BUILDING (SRB)

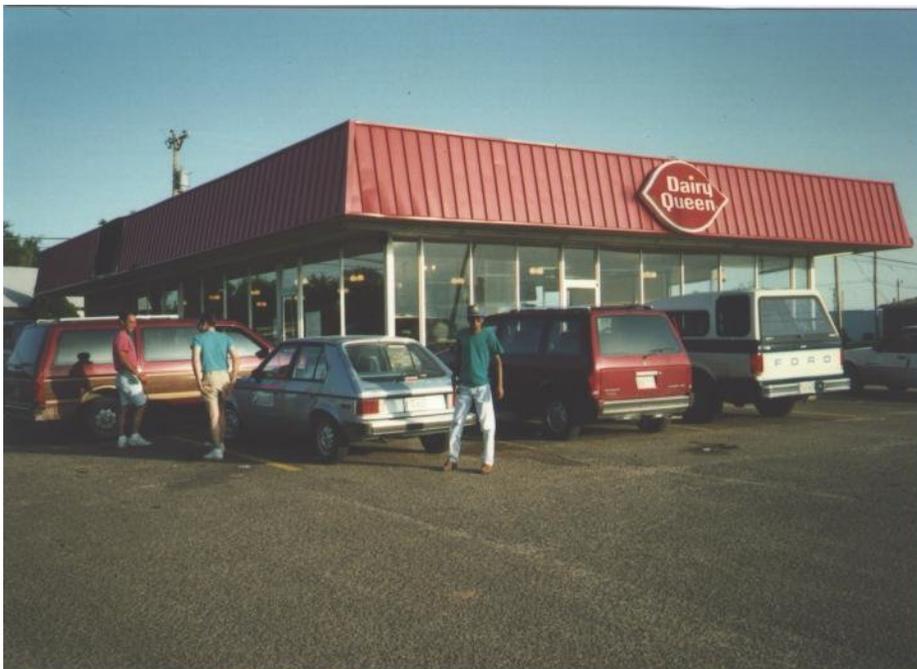
SRP: DOD 3: Broken glass in windows and doors

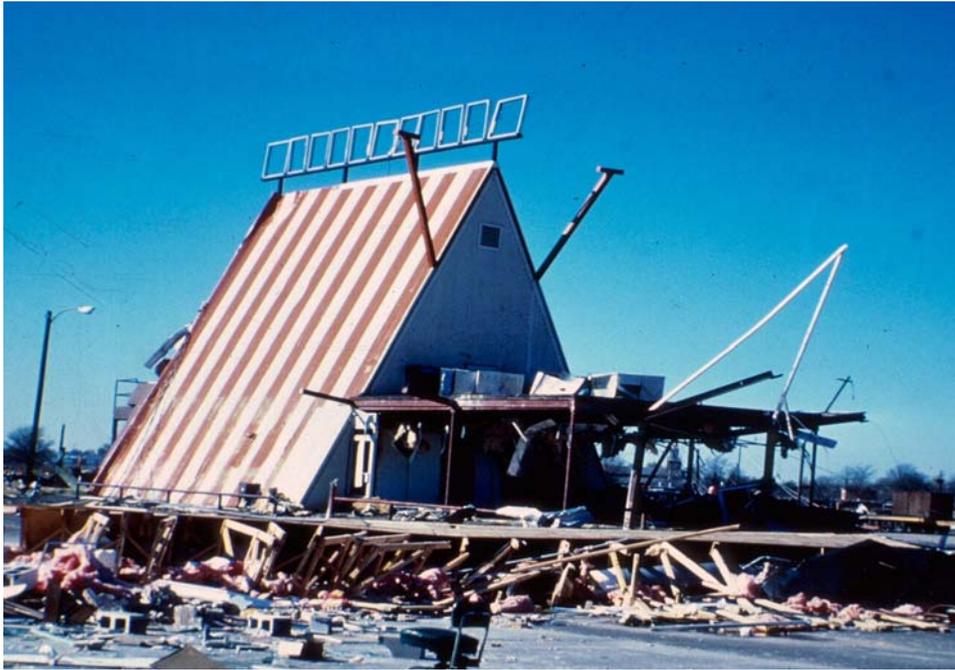
SRB: DOD 5: Canopies and covered walkways destroyed

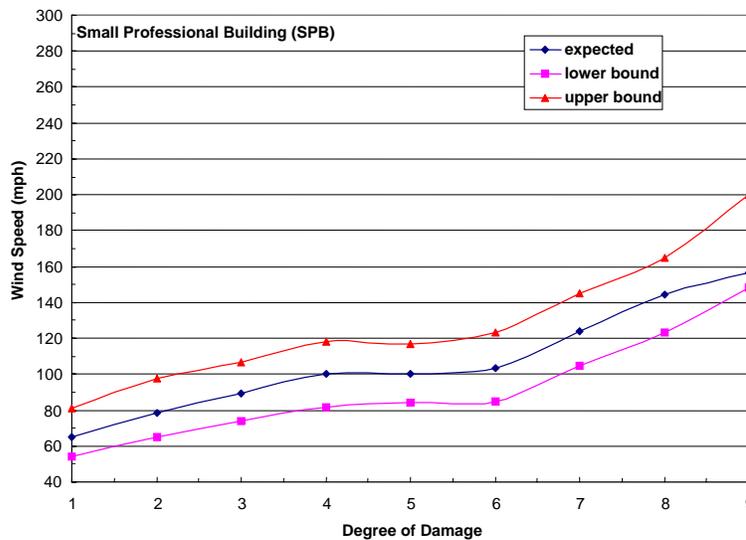
9. SMALL PROFESSIONAL BUILDING (SPB)

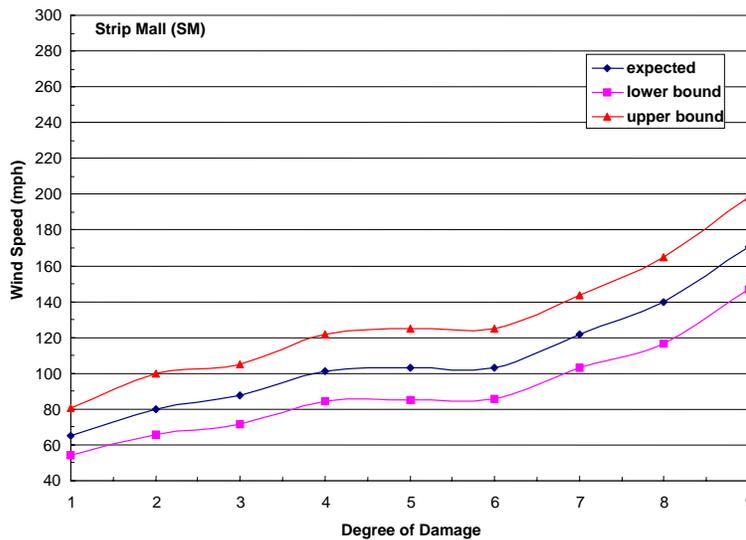
* DOD is degree of damage

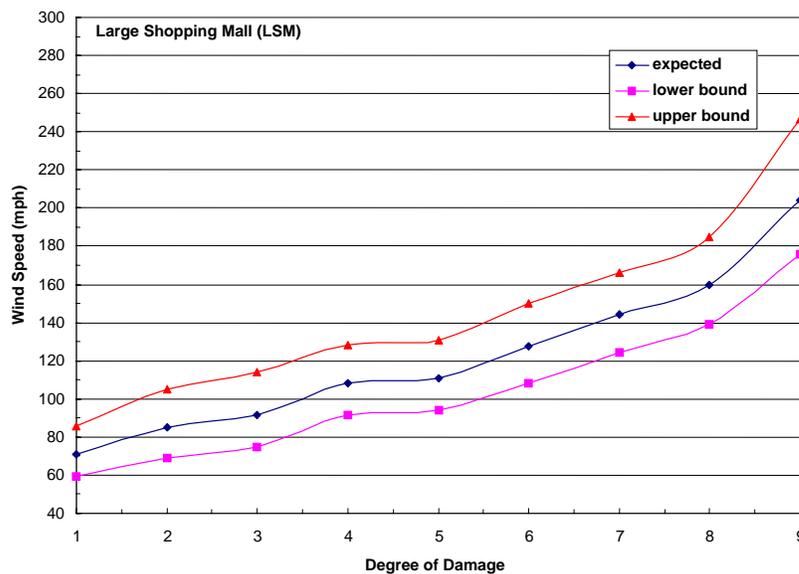
11. LARGE SHOPPING MALL

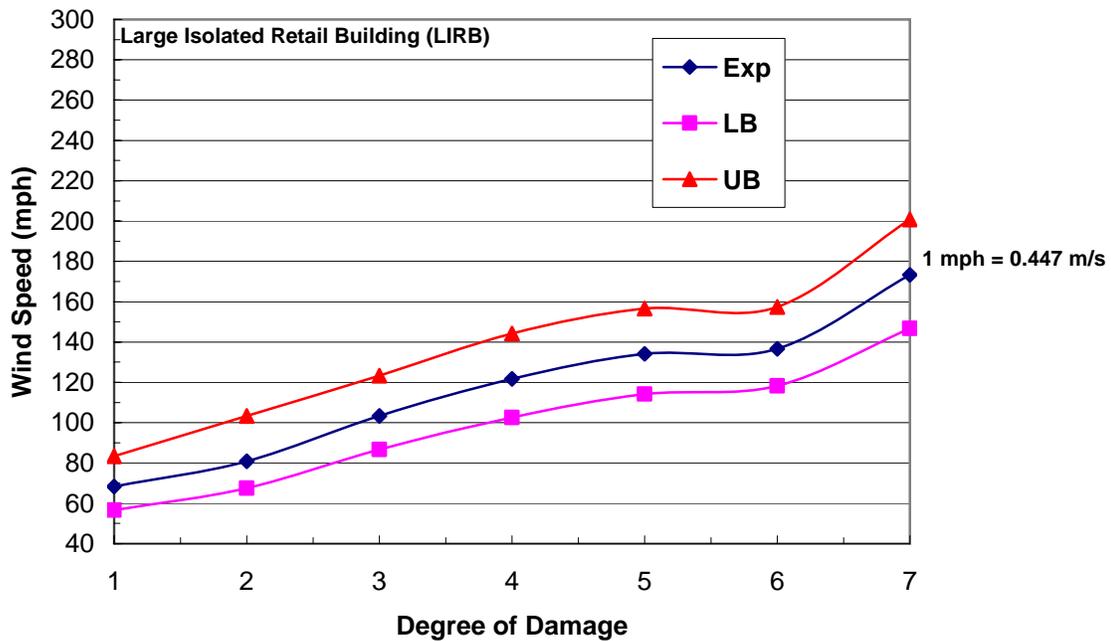
12. LARGE ISOLATED RETAIL BUILDING

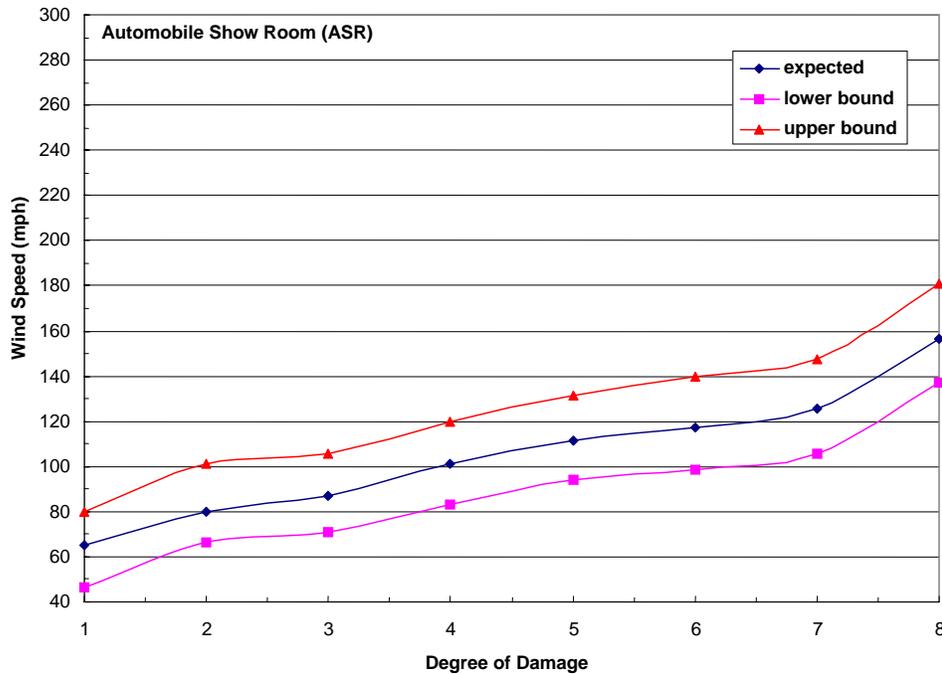
13. AUTOMOBILE SHOWROOM (ASR)

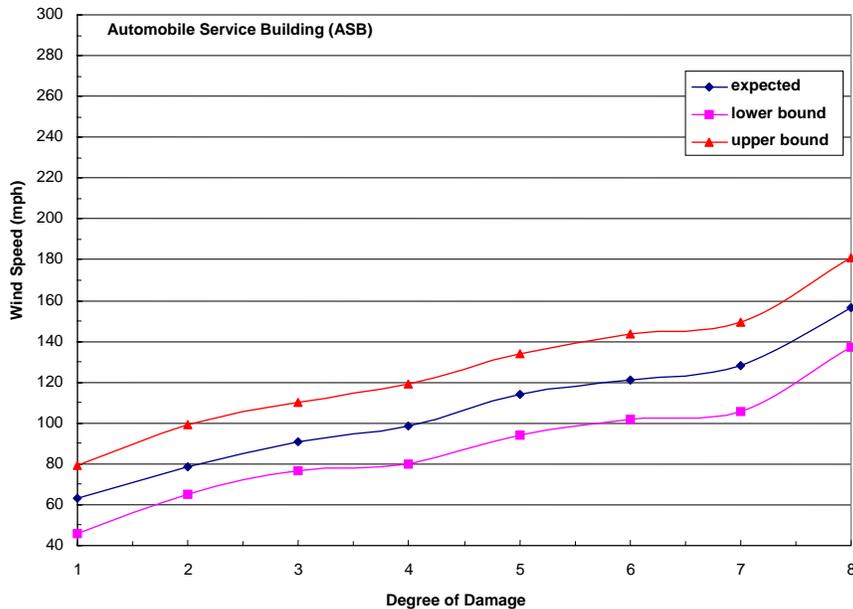
14. AUTOMOBILE SERVICE BUILDING (ASB)

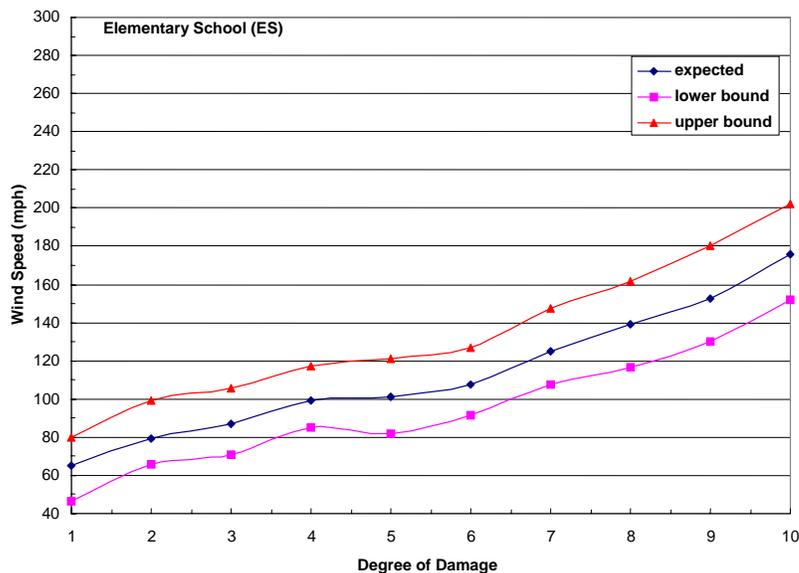
15. ELEMENTARY SCHOOL (ES)

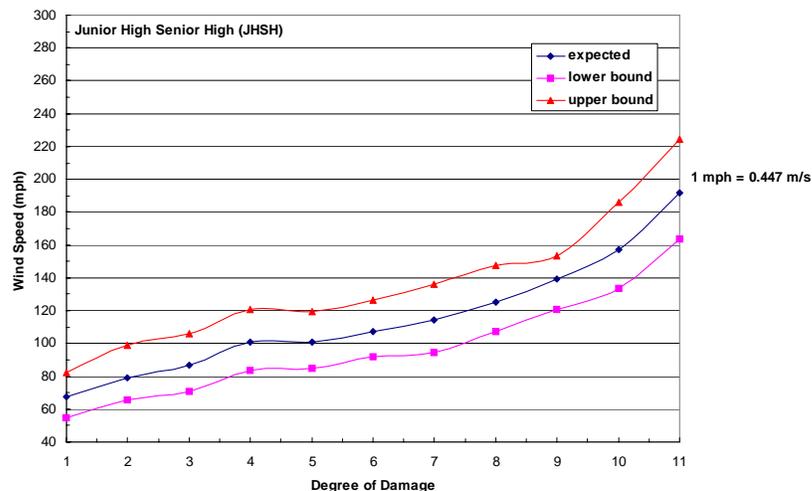
16. JUNIOR OR SENIOR HIGH SCHOOL (JHSH)

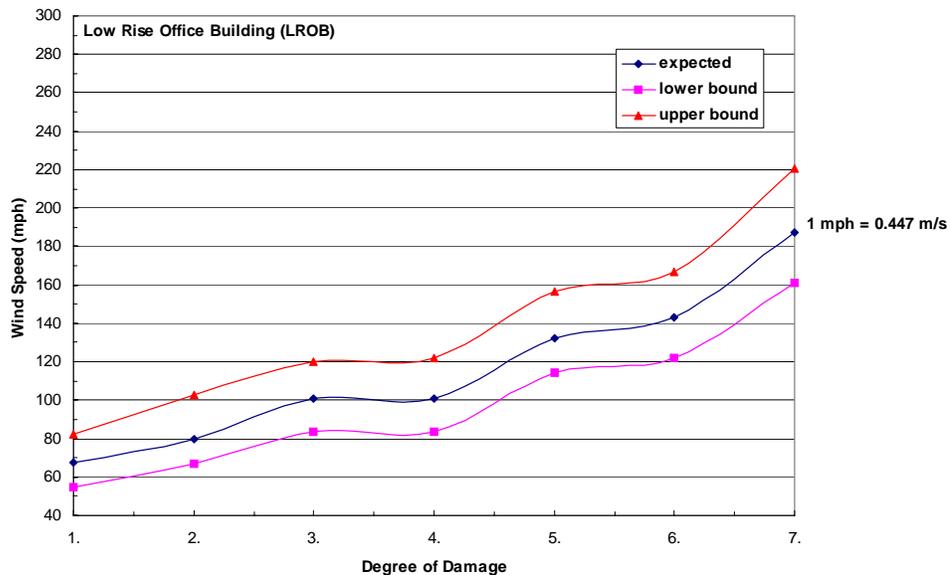
17. LOW-RISE BUILDING 1-4 STORIES (LRB)

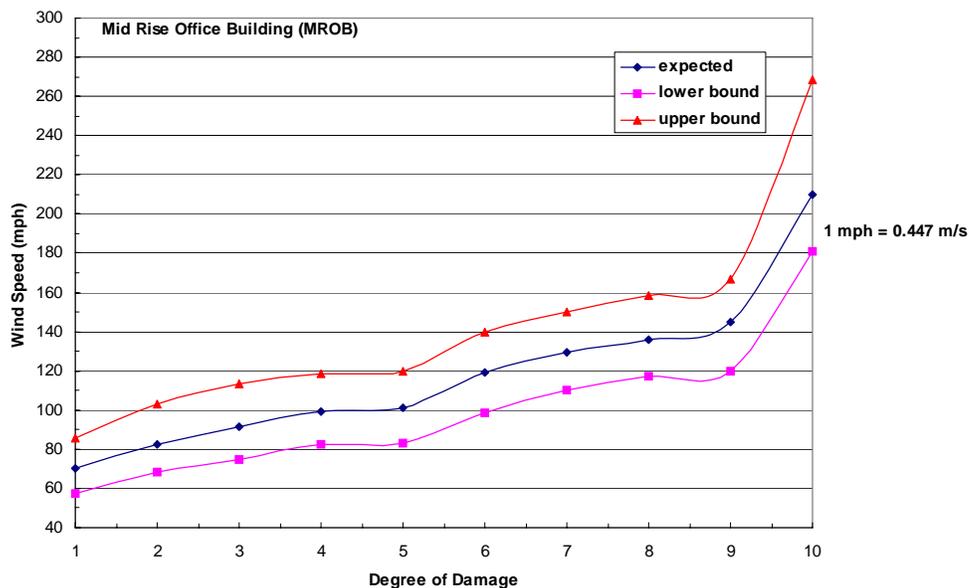
18. MID-RISE BUILDING 5-20 STORIES (MRB)

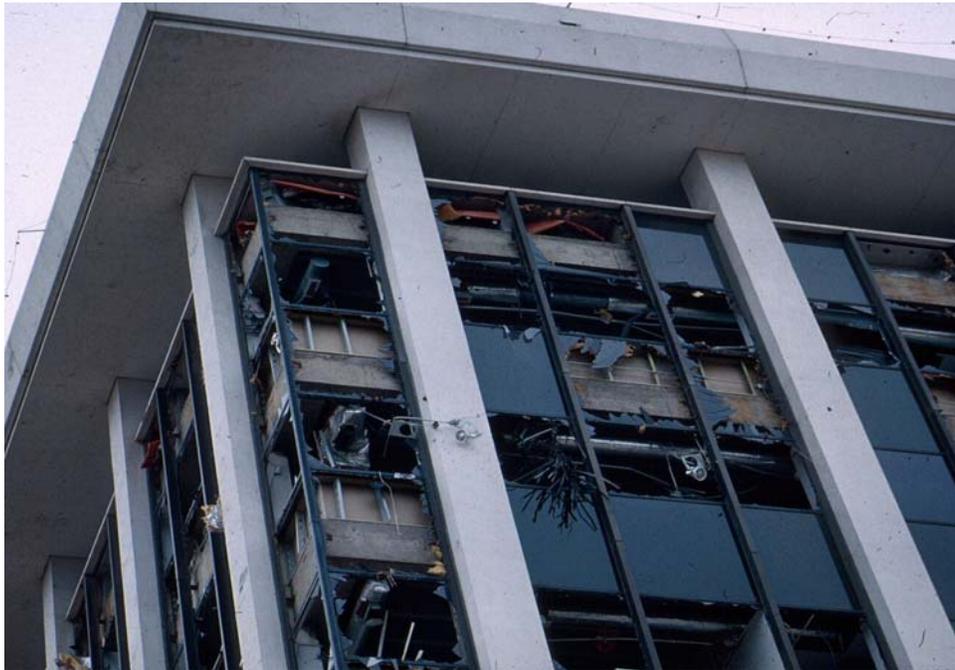
MRB: DOD 5: Broken glass in curtain walls; damage to building interior

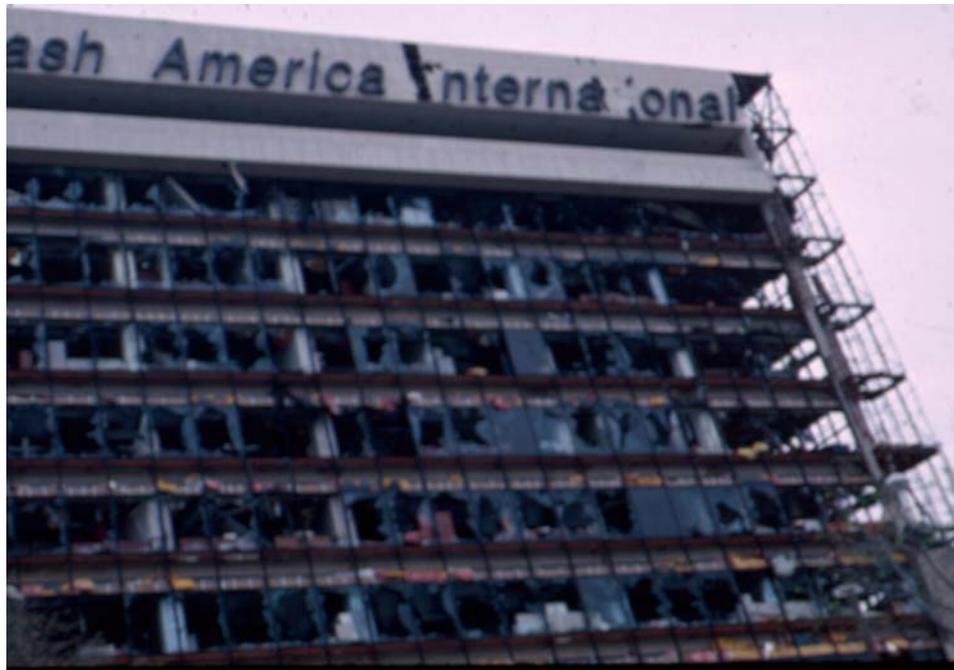
MRB: DOD 9: Significant damage to curtain walls and some interior walls

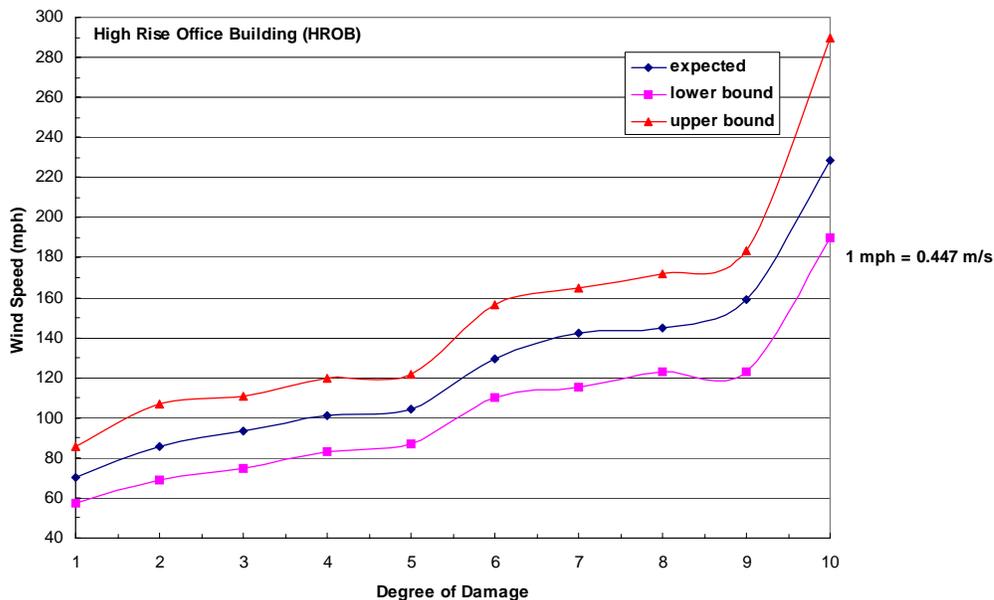
19. HIGH-RISE BUILDING – GREATER THAN 20 STORIES (HRB)

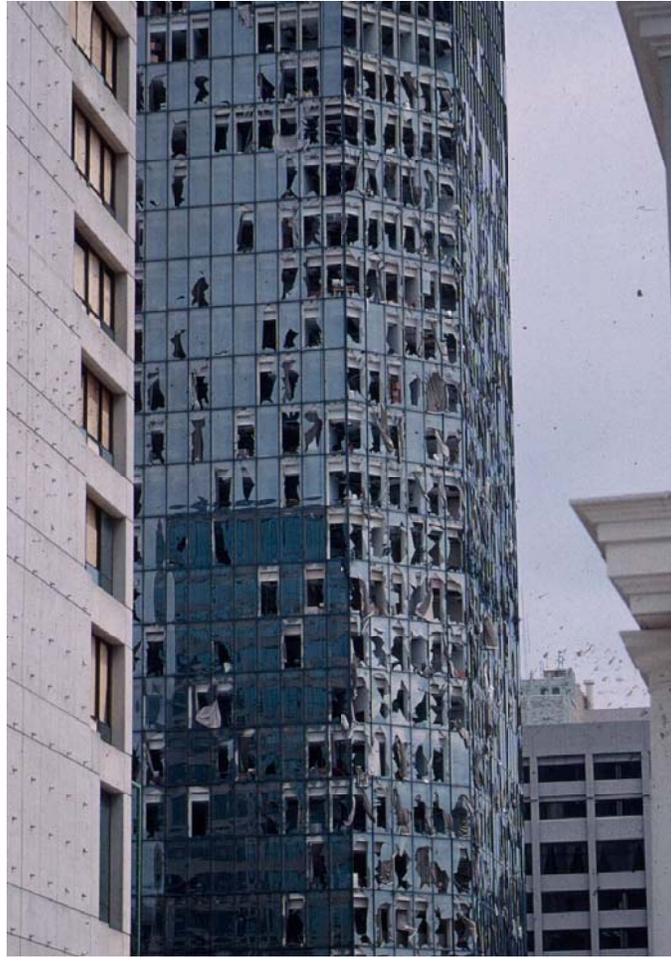
HRB: DOD 8: Broken glass in curtain wall; significant damage to building interior

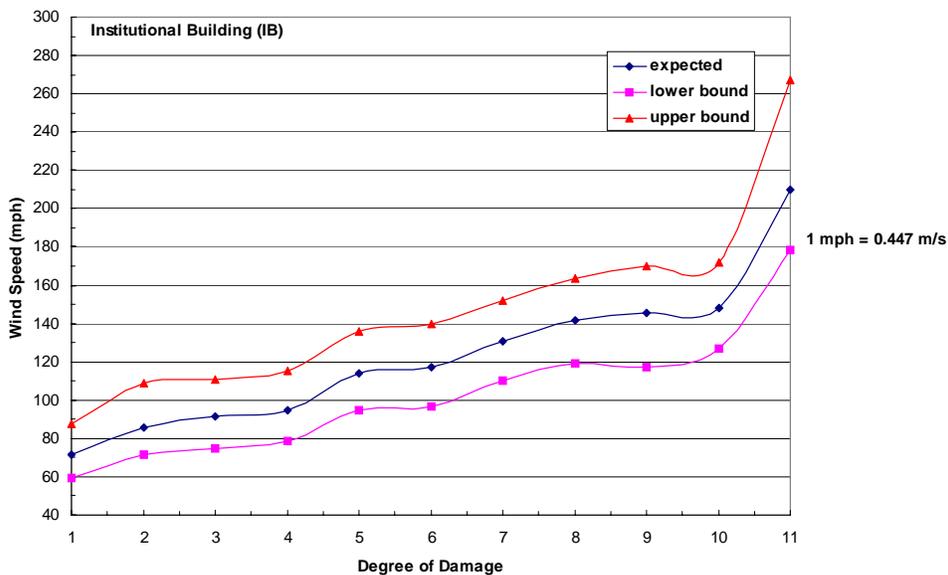
20. INSTITUTIONAL BUILDING (IB)

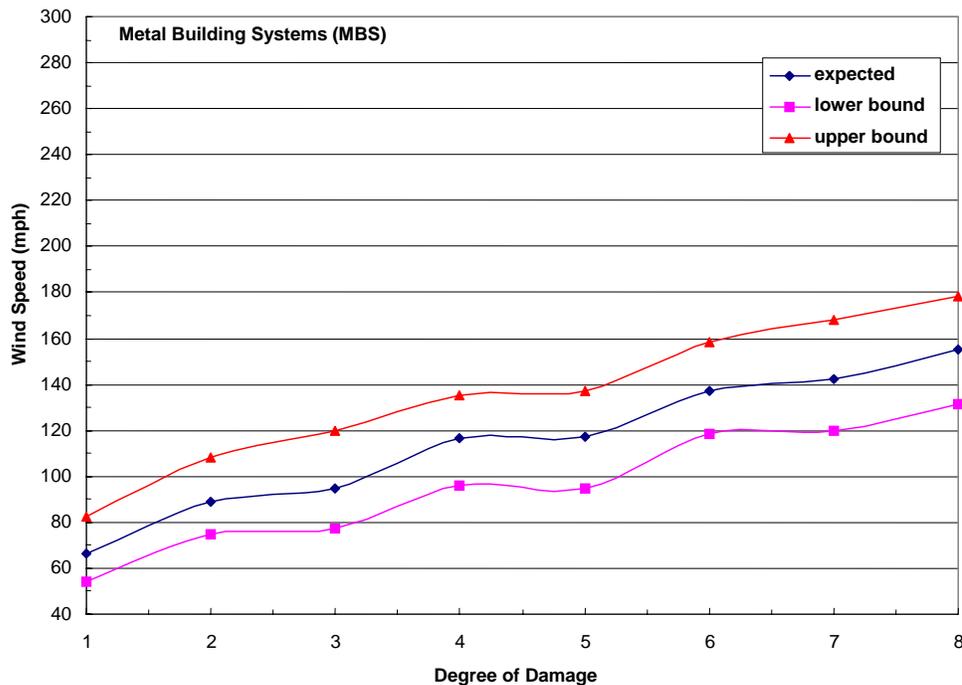
21. METAL BUILDING SYSTEM (MBS)

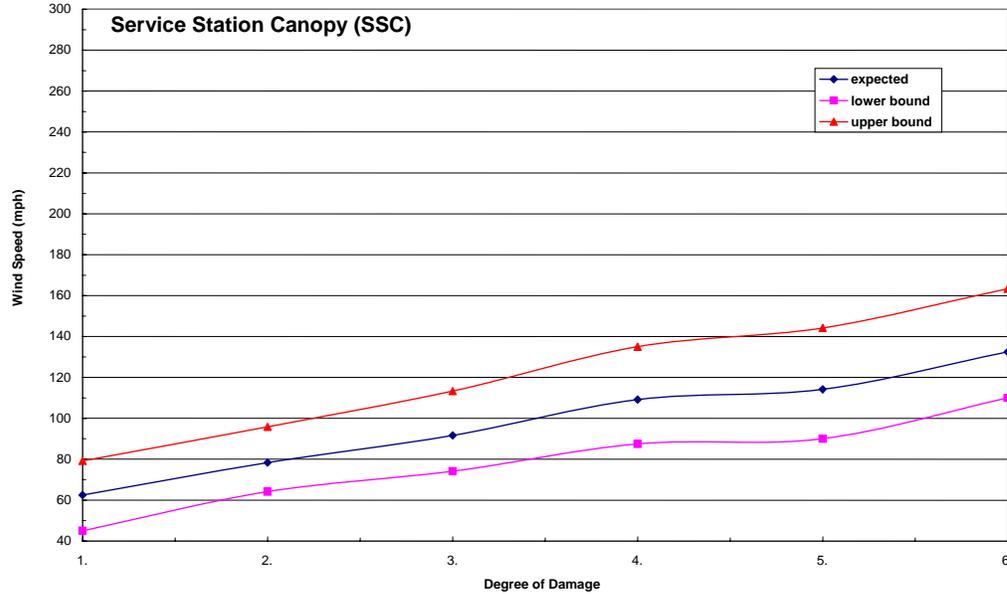
22. SERVICE STATION CANOPY (SSC)

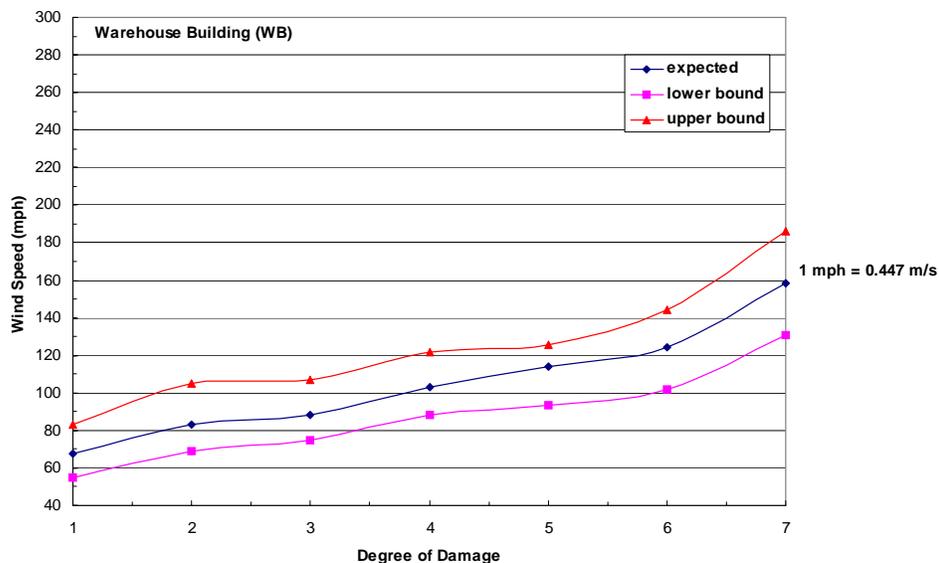
23. WAREHOUSE BUILDING (WHB)

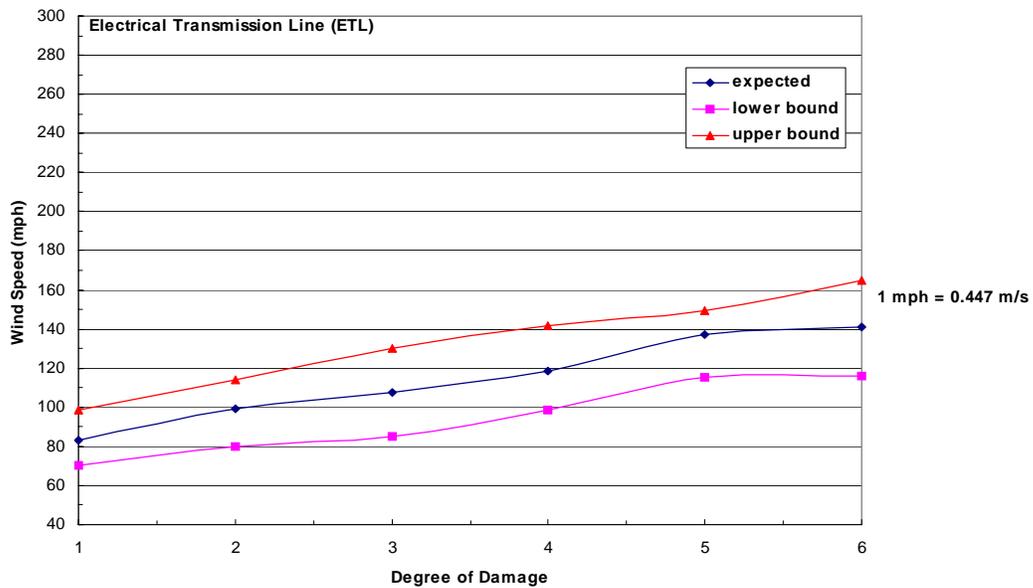
24. ELECTRICAL TRANSMISSION LINE (ETL)

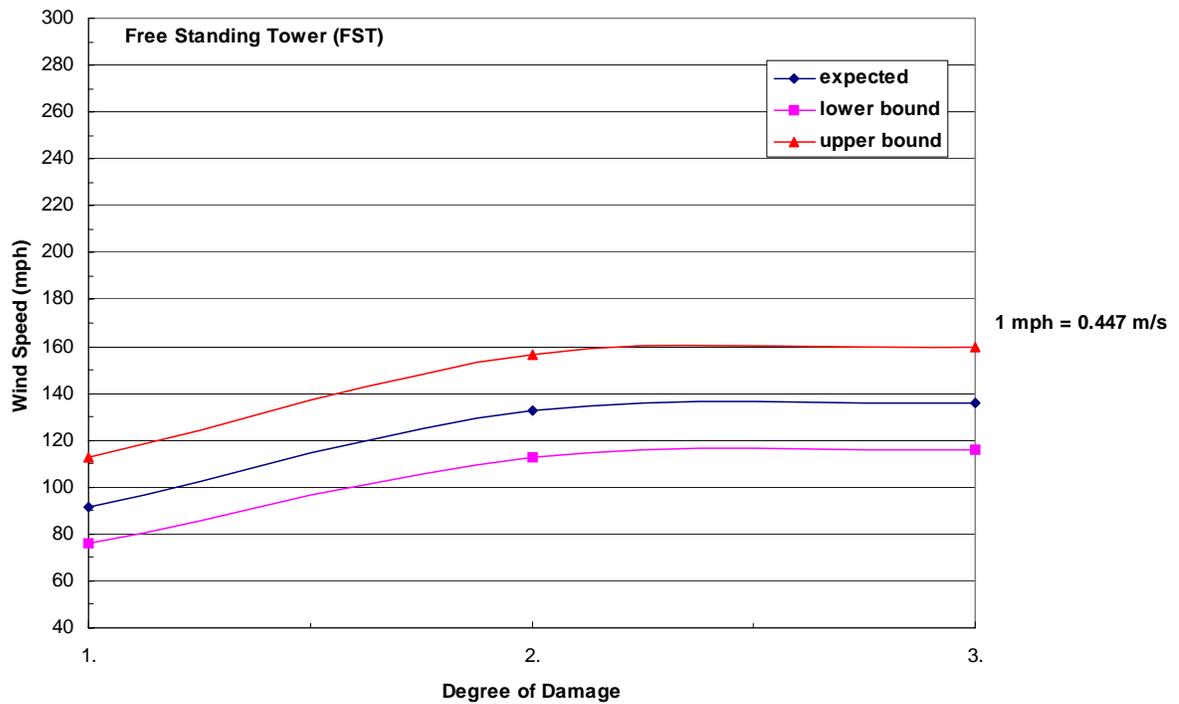
25. FREE-STANDING TOWERS (FST)

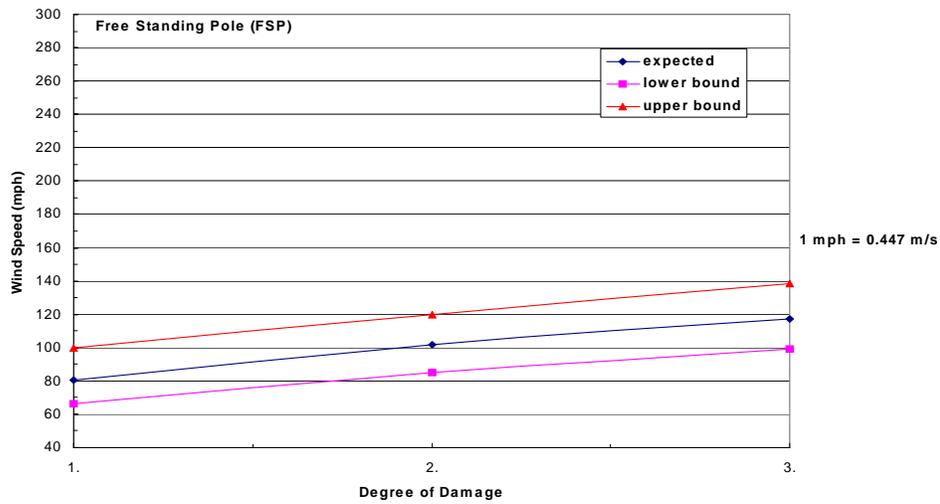
26. FREE-STANDING LIGHT POLES, LUMINARY POLES, FLAG POLES (FSP)

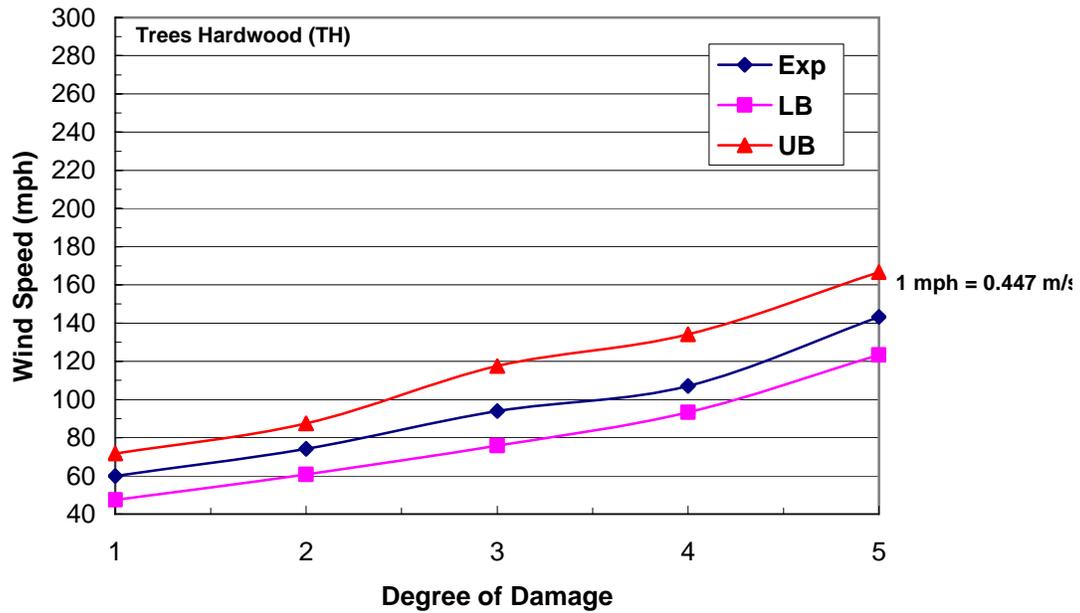
27. TREES HARDWOOD (TH)

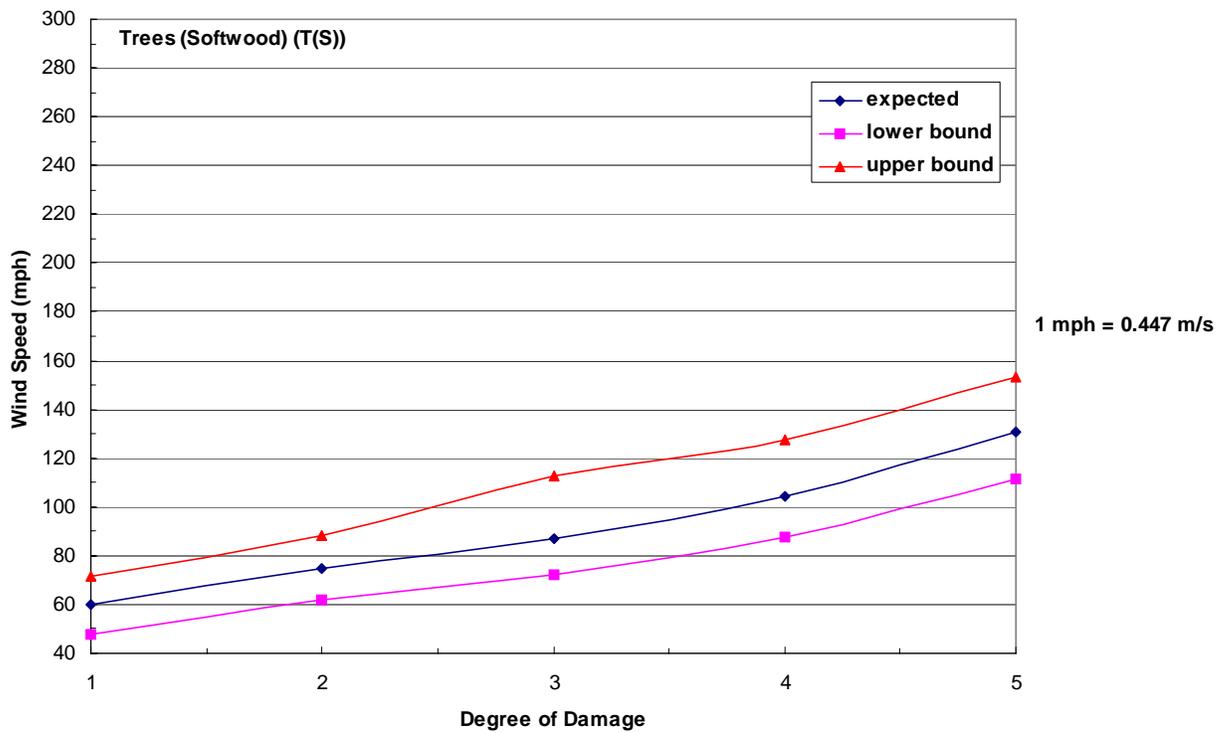
* DOD is degree of damage
